SERVICE BULLETIN

TS-430S INTERMITTENT PLL UNLOCK IN FM/AM

10-17-84

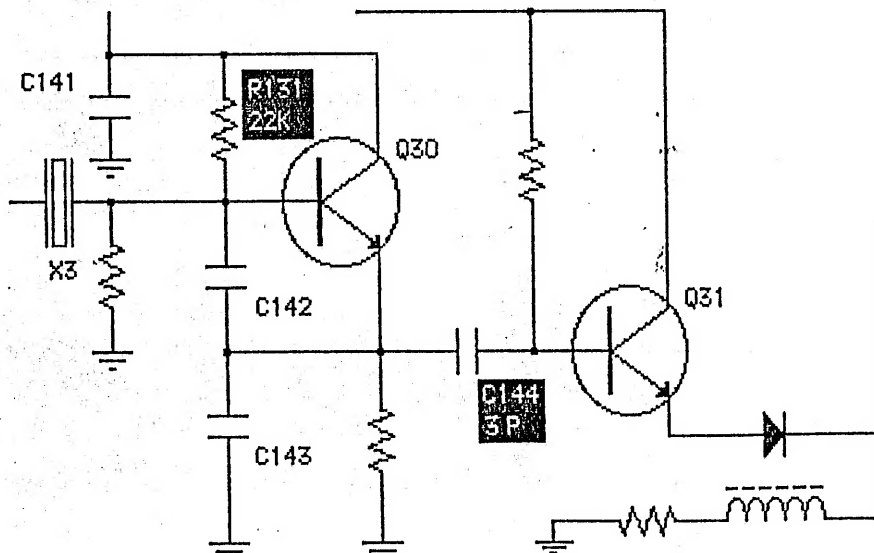
Some owners of the TS-430S have reported intermittent loss of Transmit and Receive when operating in the FM or AM modes, along with a loss of the Digital Display.

The cause of this may be due to a loss of the FM/AM Heterodyne Oscillator signal. Replacing the components listed below will correct most instances of this failure.

On the CONTROL UNIT (X53-1290-00) change R131 to a 22 K Ω 1/4 watt carbon resistor (RD14CB2E223J), and change C144 to a 3 pF 25 v disc ceramic capacitor (CC45SL1H050C).

No realignment is required.
